**324 N. Main Street, Davenport IA – Partial Collapse
Preliminary Investigative Report**

LF232566 / WBG202306
August 15, 2023

White Birch Group, LLC

SOCOTEC Engineering, Inc.

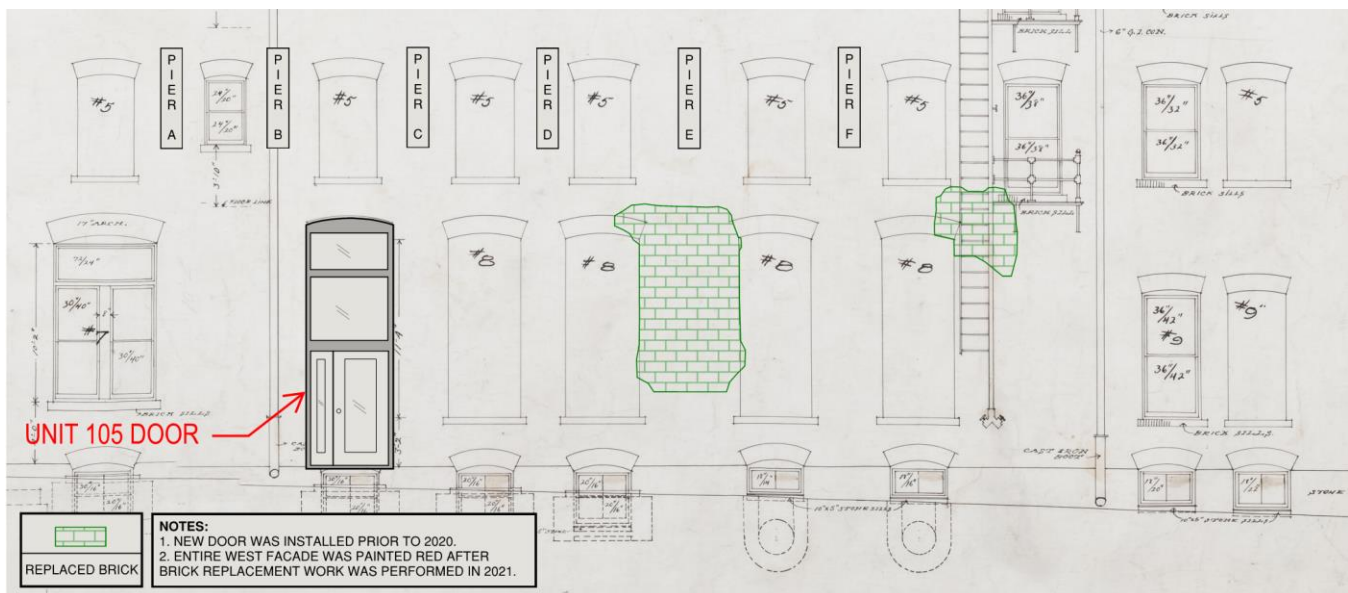
Photographs from late 2020 and early 2021 indicate that two relatively small areas of brick replacement were completed towards the southern end of the west elevation. However, there are no engineering reports or related documents on file that designate the scope or methodology for these repairs. In addition, by May 2021 photographs indicate that the entire west elevation was painted red. **Fig. 6** below provides an excerpt from the original 1906 elevation drawings, annotated with areas of brick replaced during the 2020 and 2021 repair campaigns.

Fig. 6. Original 1906 west elevation drawing indicating 2021 repair locations (Annotations by WBG/SEI)

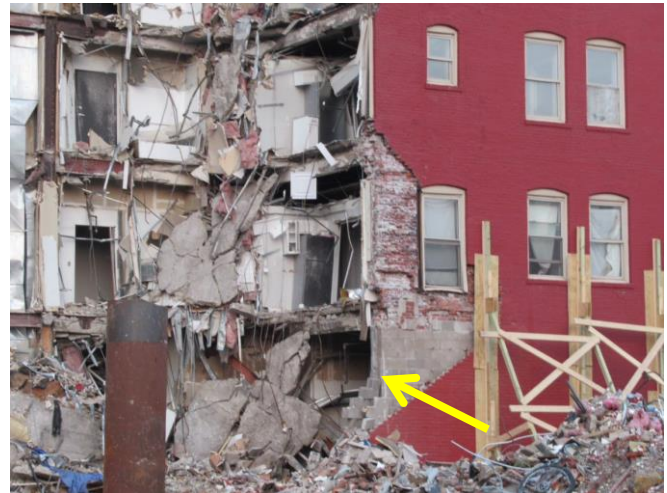
Fig. 21. Photograph of the southern extent of the collapsed portion of the Building taken June 4, 2023. Arrow indicates construction joint of new CMU wall construction.

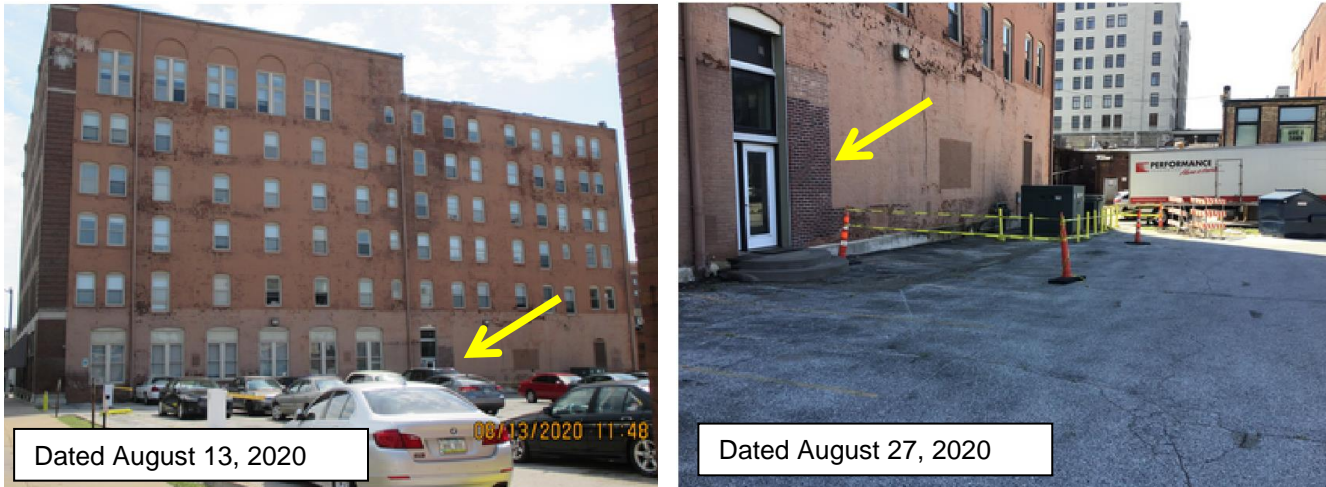
Fig. 26. Images of the west elevation (Ref: City Reinspection Reports, Task ID: 20-7839 and 20-58268). Yellow arrow points to area of apparent previous repair.

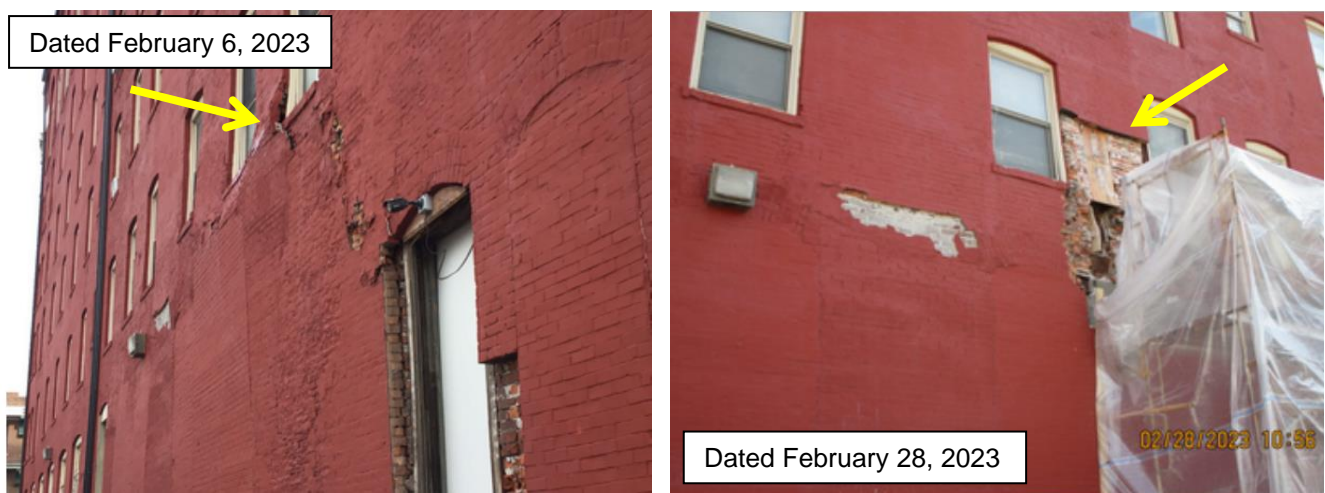
Select photographs from the report are included in **Fig. 33**. The photographs indicate areas of distress observable in the wall in early February. Later in the month a scaffolding was erected and some brick removal was underway.

Fig. 33. Image of the west elevation adjacent to the rear door taken in February, 2023 (Ref: City Reinspection Report, Task ID: 21-6454). Yellow arrow points to apparent location of deterioration of the brick and later replacement in progress.

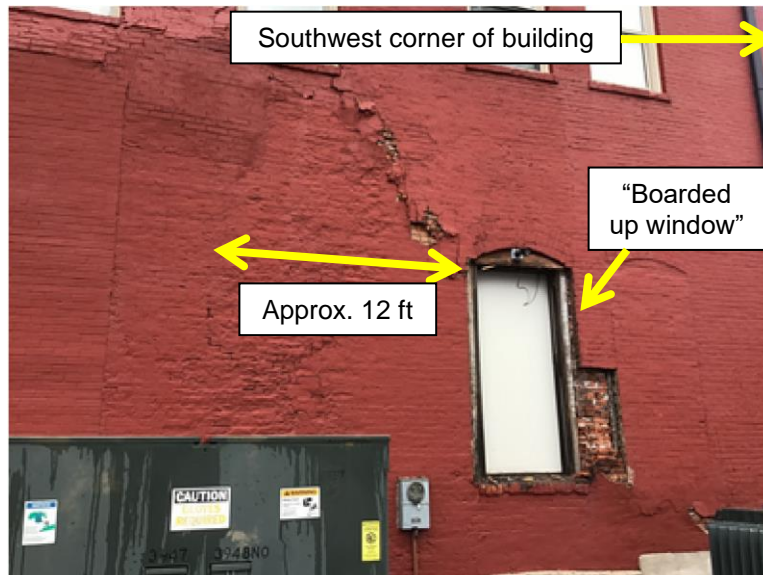
Fig. 35. View of assumed area of specified repair by SSE’s February 8, 2023 letter (Ref. City Report Task ID: 23-6454). Annotation by WBG and SEI.

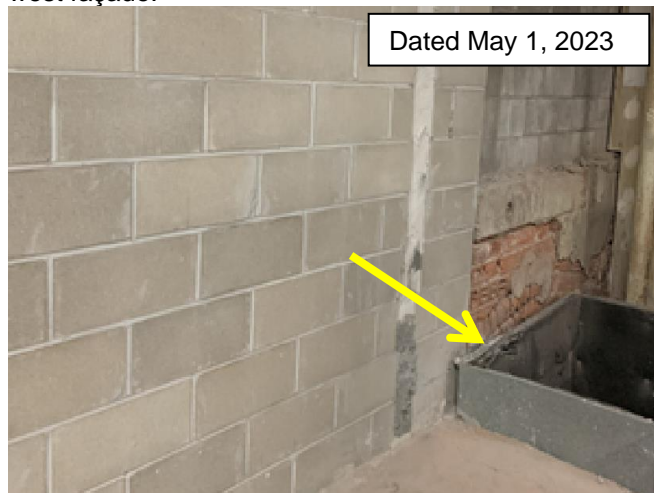
Photograph indicates area of replaced CMU from inside. Note mechanical opening in floor.

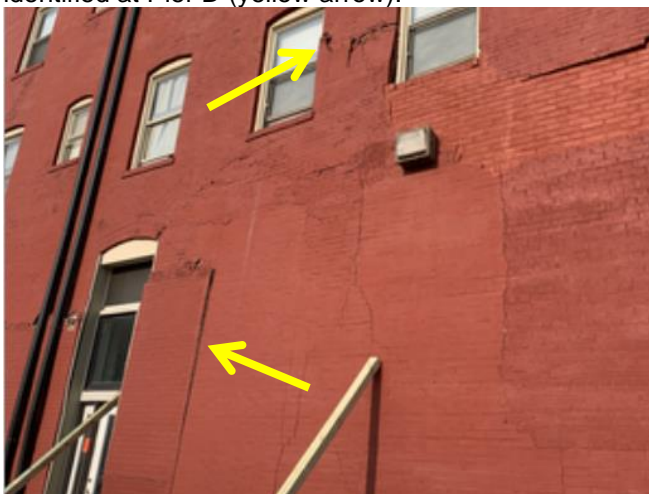
Overall view of portion of west elevation south of door. Note numerous areas of deterioration to wall.

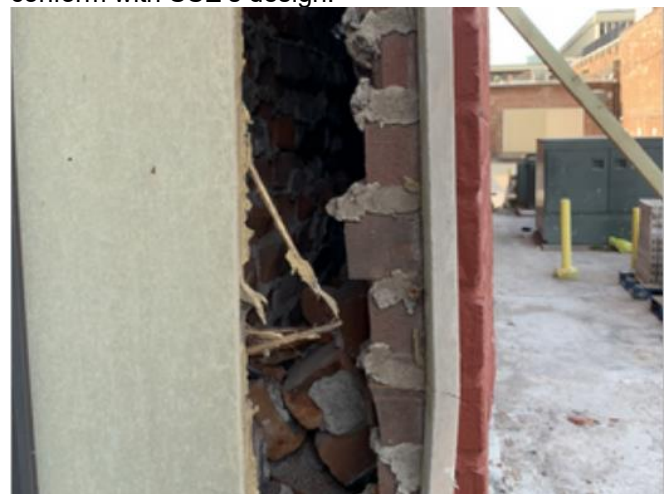
Detail view of bowing brick at south jamb of doorway. Note bricks accumulated in gap between wythes.

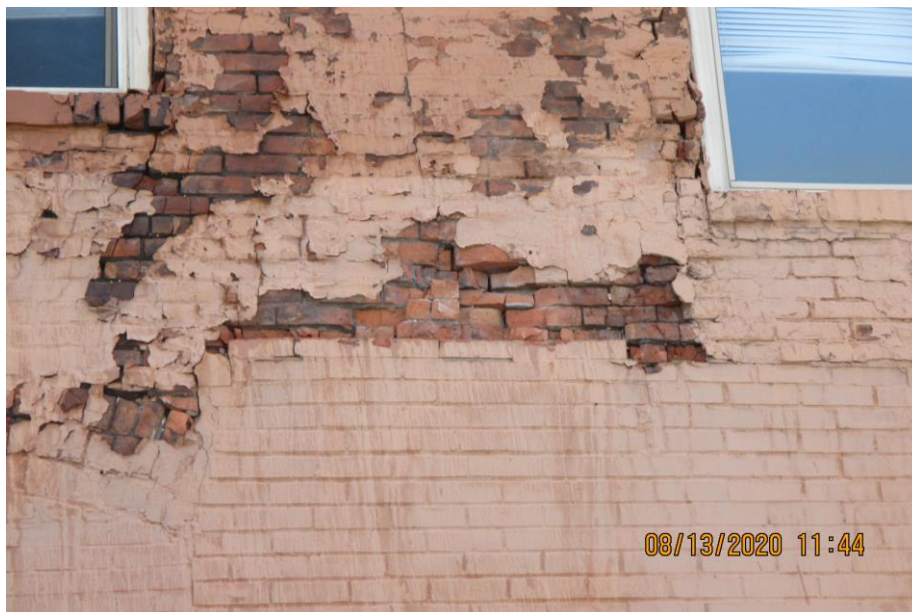
Photograph 4: August 2020 image of west elevation from City report.
Note open mortar joints, spalling brick faces, and other masonry distress.

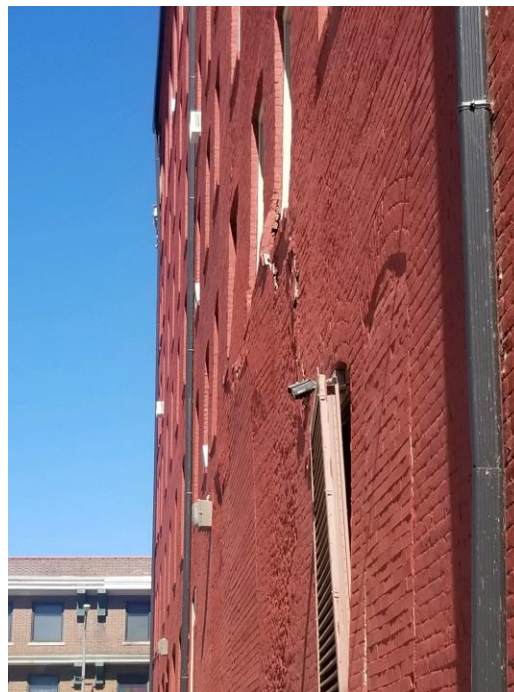
Photograph 10: February 2023 image from City file 23-6454.
Note displaced masonry and louvers.

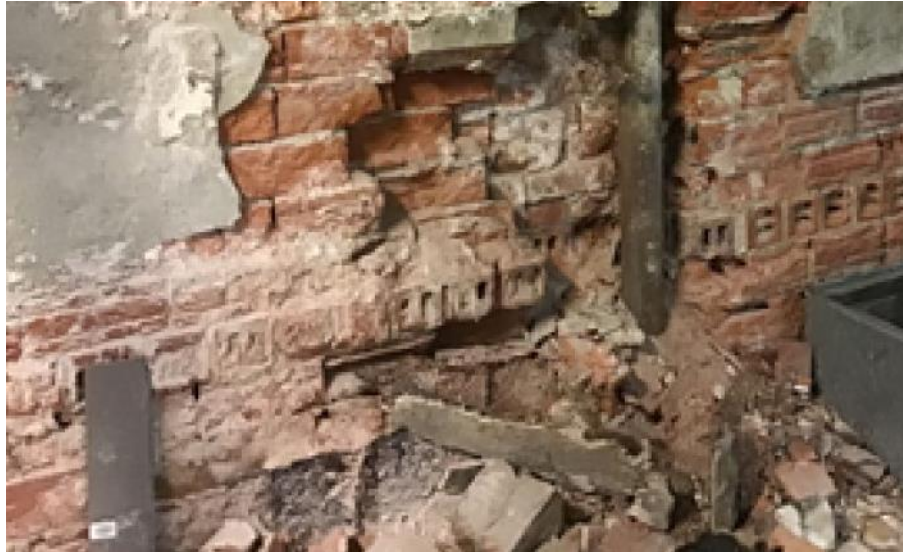
Photograph 11: February 2023 image from City file 23-6454.
Note distress and damage at interior masonry.

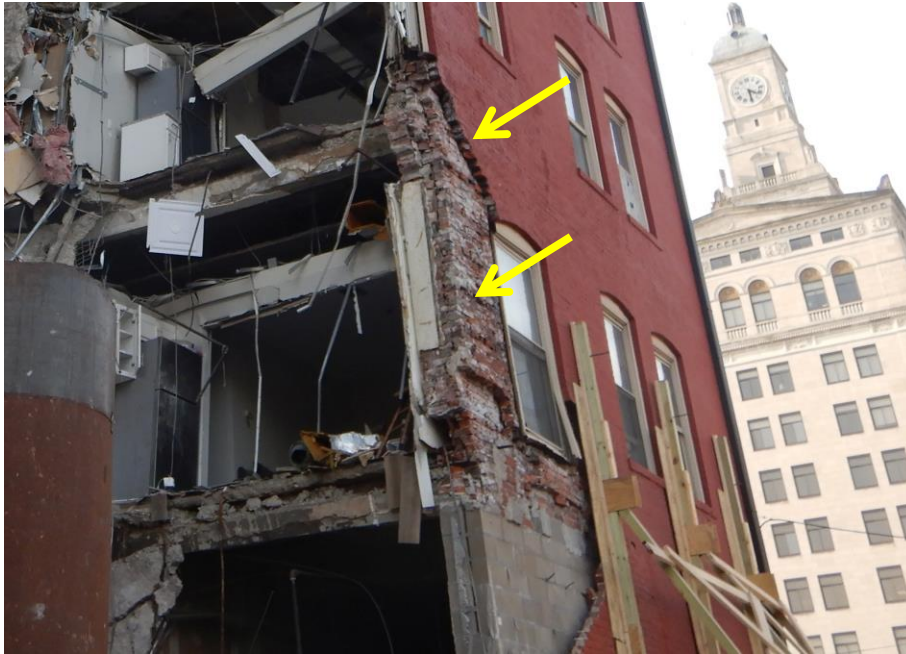
Photograph 19: Post-collapse view at wall cross section.
Note outer 2 wythes of brick masonry not bearing on CMU replacement wall.

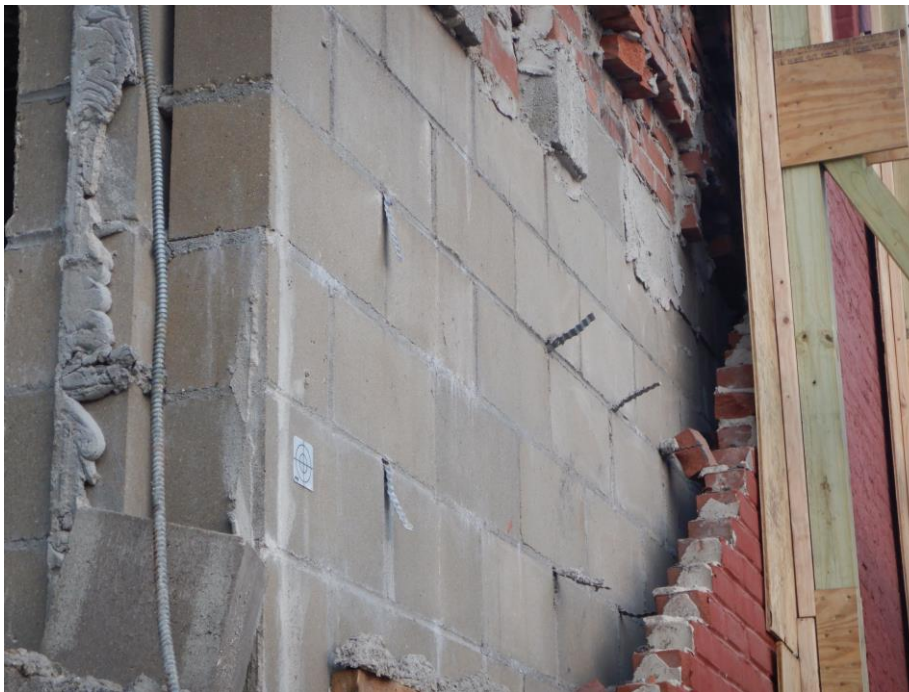
Photograph 20: Post-collapse image of CMU wall constructed in May 2023.
Note corrugated brick ties not engaging outer wythe of brick masonry.

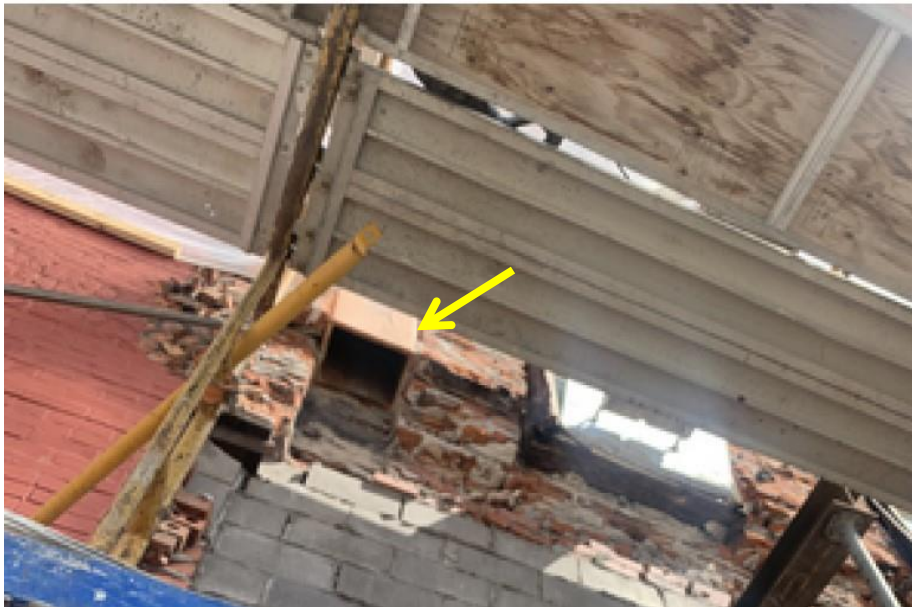
Photograph 26: Image from City file 23-9778 exhibiting April 2023 repair work.
Note large vertical chase embedded within wall at Pier F.

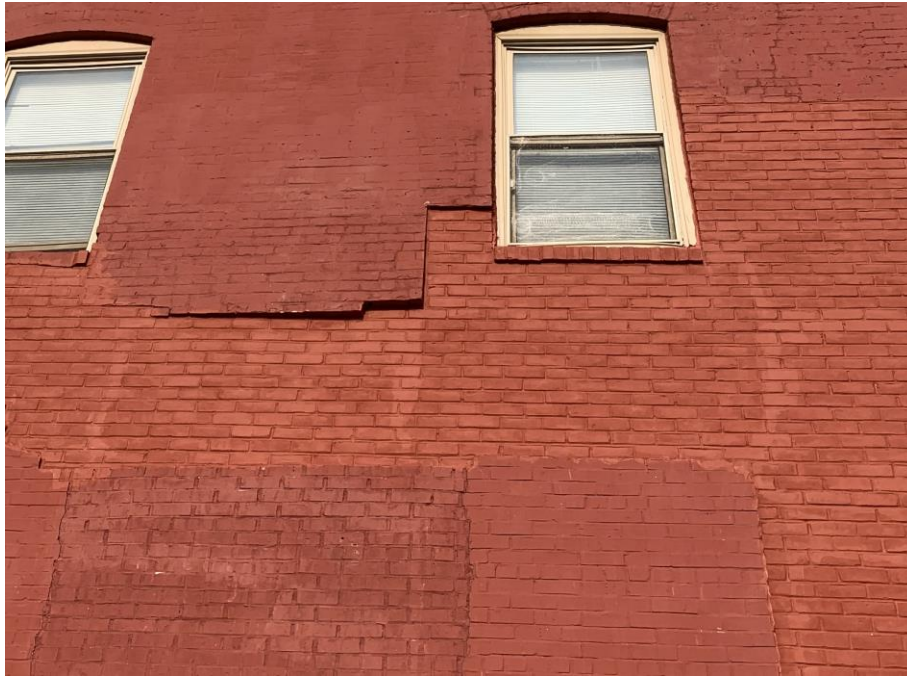
Photograph 27: Image from City file 23-30329.
Note mis-aligned masonry at Pier E brick replacement locations.

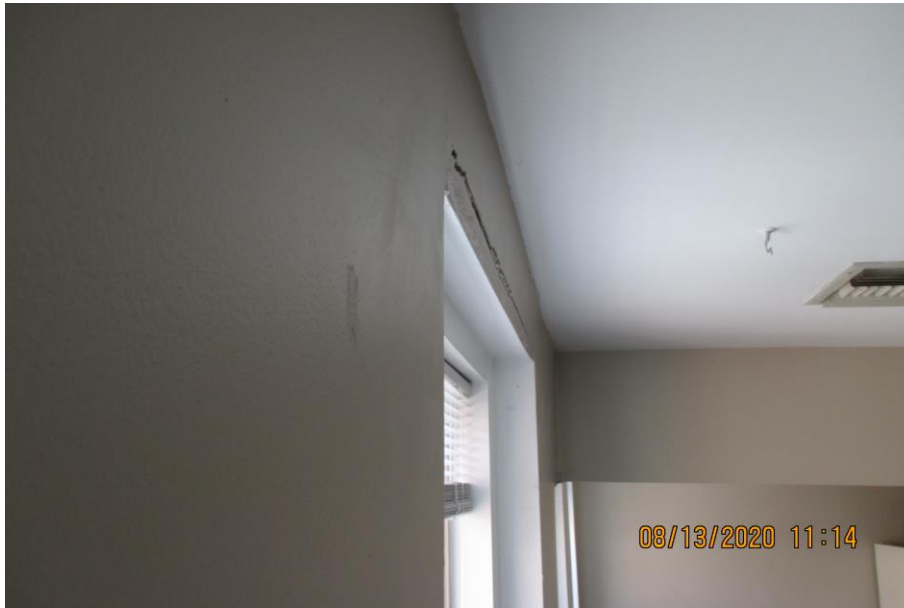
Photograph 29: Image from City file 20-7839.
Note indications of water infiltration and distress at ceiling and window head.

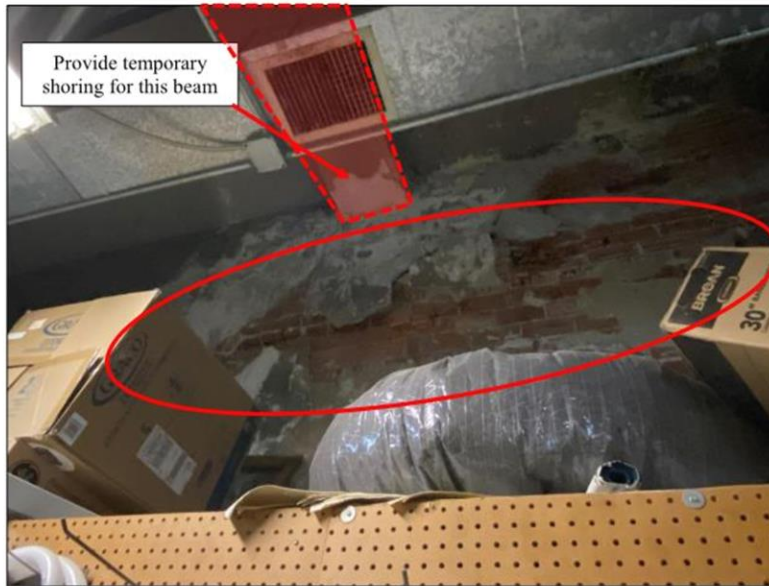
Photo 1 – Damaged Brick & Beam to Support
