**324 N. Main Street, Davenport IA – Partial Collapse
Preliminary Investigative Report**

LF232566 / WBG202306
August 15, 2023

White Birch Group, LLC

SOCOTEC Engineering, Inc.

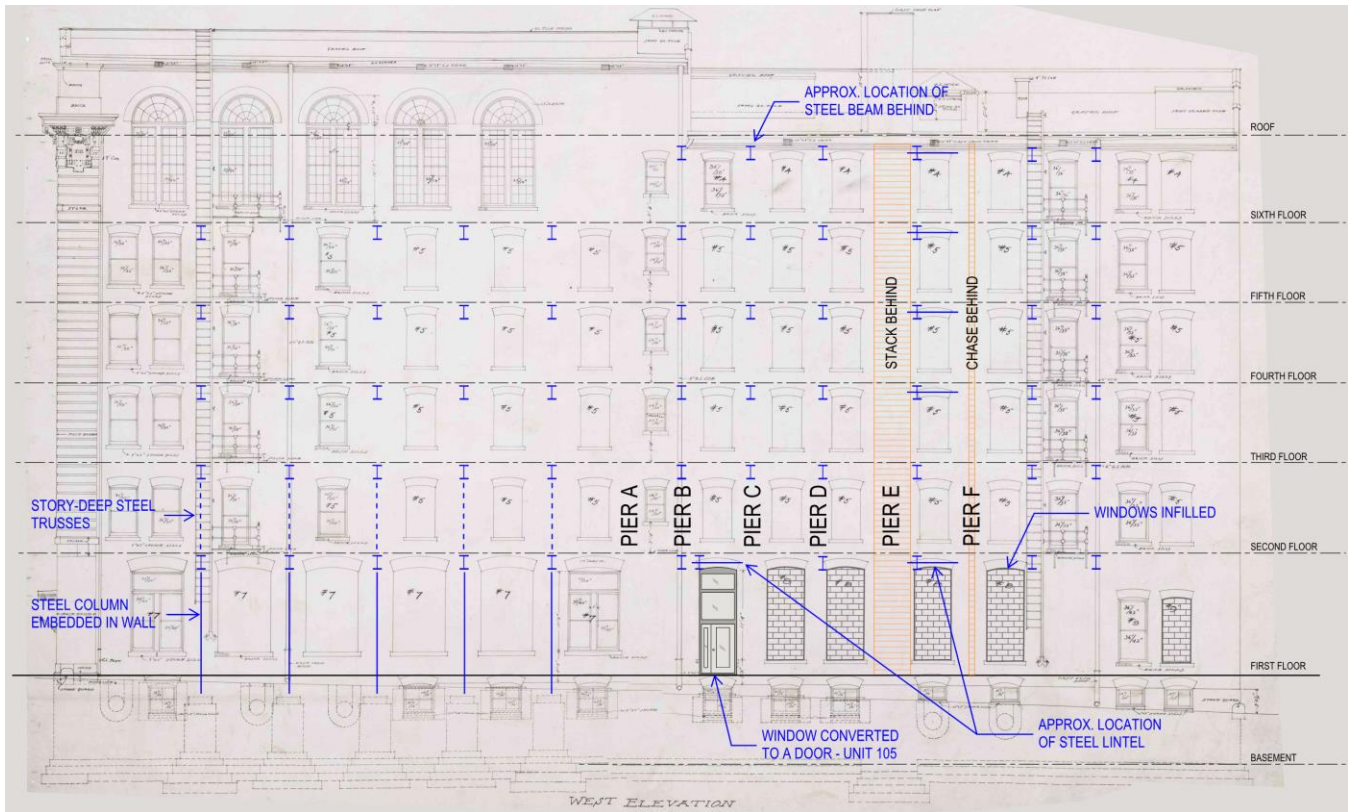
The west wall, or rear elevation of the building was constructed of brick masonry with brick arched window openings and brick sills. The west elevation is the focus of this investigation. **Fig. 2** shows the west elevation with added annotation indicating the approximate location of the structural steel framing behind. Piers A through F, as assigned by WBG and SEI, have been identified in this image and will be referenced throughout the report. Areas of note include:

- > A steel lintel was provided above the window between Piers B and C at the second floor to support the second steel beam at this location. Further steel lintels were located between Piers E and F at the second, fourth, fifth, and sixth floors as well as the roof.

Fig. 2. West elevation of the Building (Ref. Drawing 16, Temple, Burrows, and McLane, Architects). Annotation by WBG and SEI.

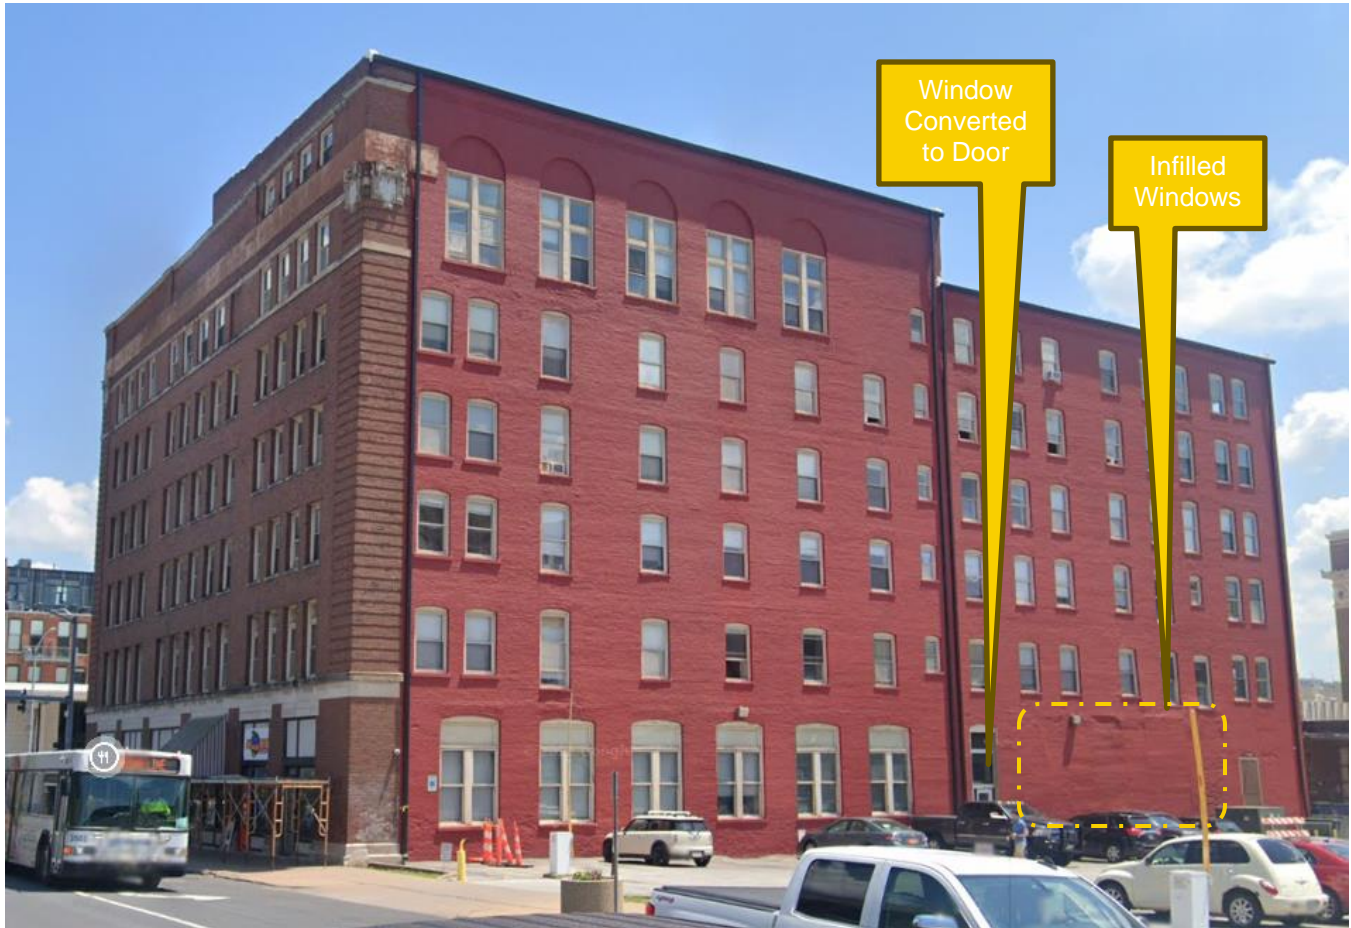
According to the permits on file, the building was converted to apartments in 1985. Other modifications to the west elevation subsequent to the original construction included infill of many of the 1st floor windows, and creation of a doorway by extending one of the existing window openings down to grade. This doorway served as the entrance to Unit 105 referenced later in this report. The fire ladders on the west elevation were also removed. At the infilled windows, concrete masonry units (CMU) or light gauge steel studs were used as backup for the new brick veneer (Fig. 4).

Fig. 4. Overall view of the west elevation of the Building (Ref. Google Streetview, dated June 2021). Annotation by WBG/SEI.

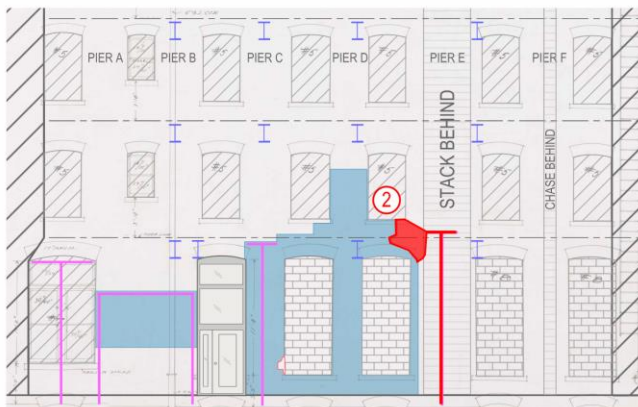
**2 MINUTES 44 SECONDS PRIOR TO COLLAPSE
BRICK PIECE AT NORTH END OF PIER E DETACHES**

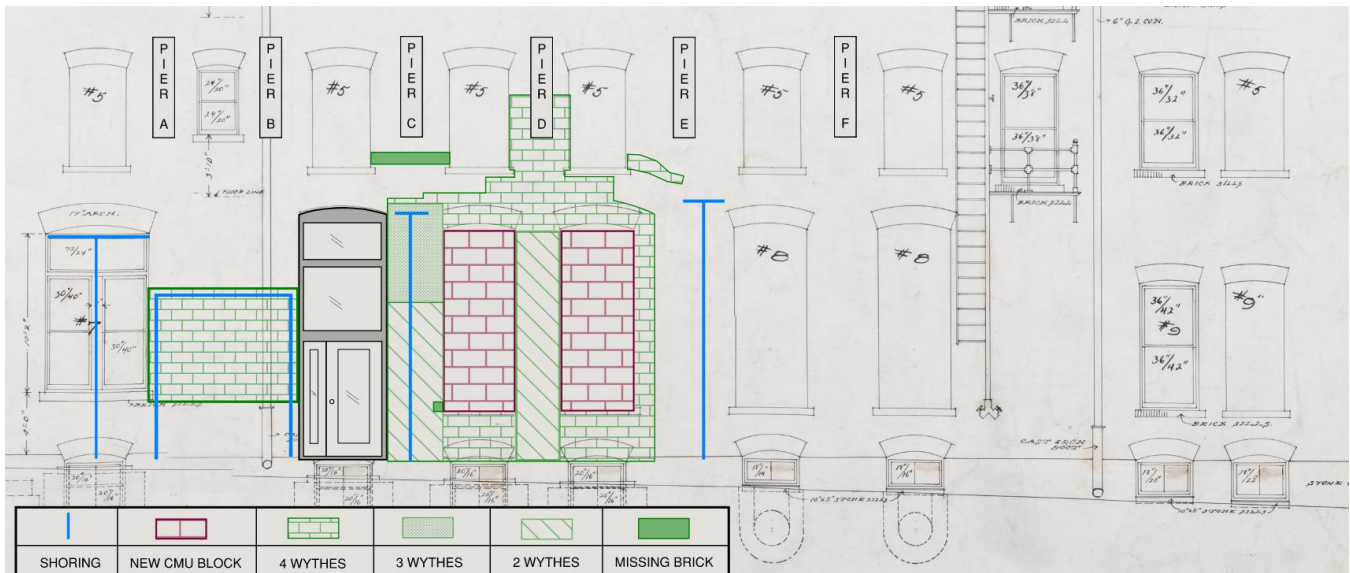
Based on a review of security camera footage, no further work was performed within the area displayed in **Fig. 16** after May 27, 2023. **Fig. 17** delineates the extent of the brick removal as evidenced in the May 27, 2023, photographs, and understood to be unchanged prior to the collapse at approximately 5:00 pm on May 28, 2023.

Fig. 17. West elevation markup indicating assumed amounts of remaining brick after brick removal prior to collapse on May 28, 2023.

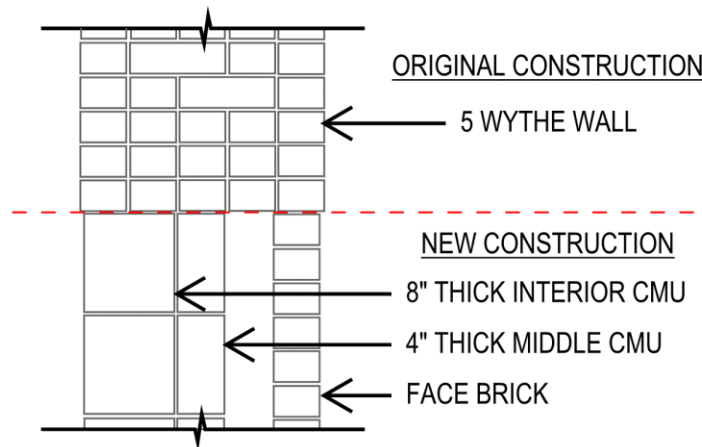
The lack of composite connection resulted in the single exterior wythe of brick masonry veneer of this configuration supporting approximately a third of the load from the composite masonry wall above, with the remaining two-thirds supported by the 12 in. of hollow CMU. This condition yields a bearing stress increase of approximately 67%, compared to a single wythe of the original construction above. The result of this increase in bearing was the visible large lateral displacement (bowing) of the brick masonry at the outer wythe.

Further, since the new CMU wall construction did not provide continuous bearing support for all 5 wythes of the masonry bearing wall above, and left one of the intermediate wythes vastly unsupported (**Photograph 18** and **Photograph 19**) some of the unsupported brick masonry above became disengaged, and the loose brick fell and collected at the base of the first-floor wall cavity between the CMU backup and the outer brick veneer. This condition exacerbated the wall distress by exerting additional forces on the brick veneer. The accumulation of loose masonry was reported by SSE in their Addendum letter dated February 28, 2023 (**Photograph 21**).

Fig. 25. Configuration of wall resulting from early 2023 repair project

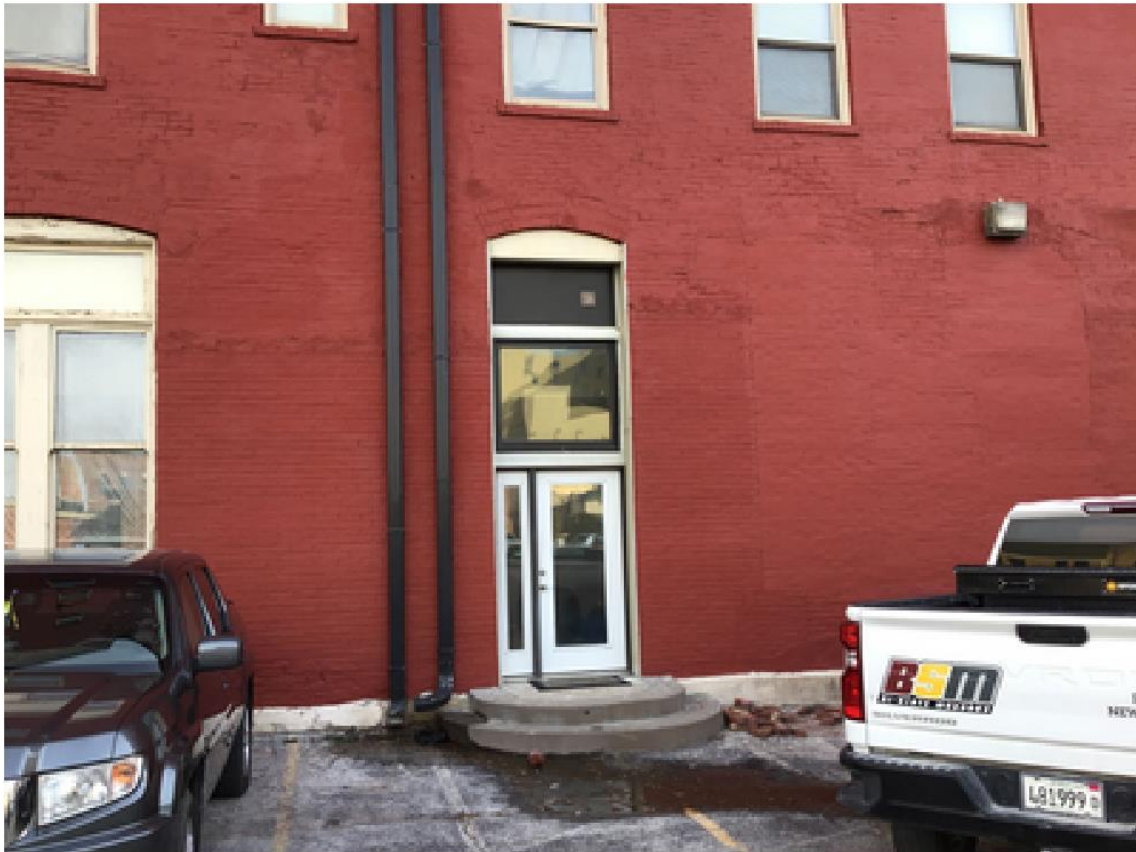
Fig. 31. Image of the west elevation adjacent to Unit 105 door taken on November 1, 2021 (Ref: City Report, Task ID: 21-64101).

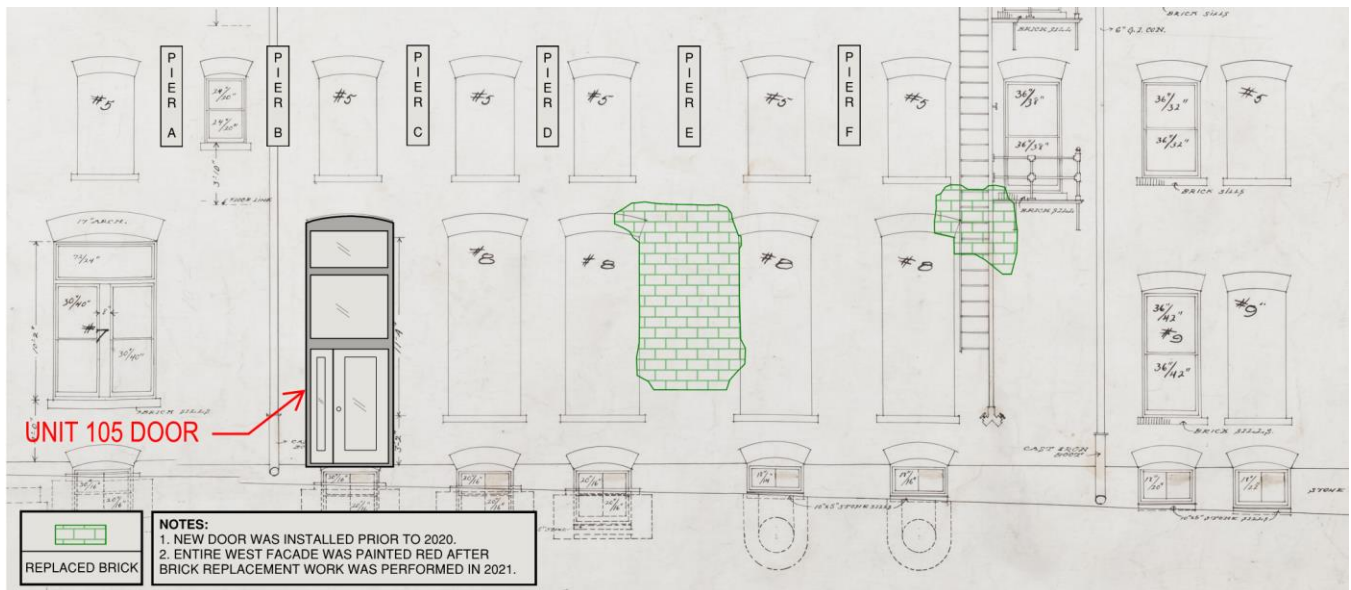
Fig. 32. West elevation markup indicating areas of repair completed in 2021.

Based on WBG and SEI's review of the available photographs, **Fig. 32** indicates the extents of repair work completed in 2021.

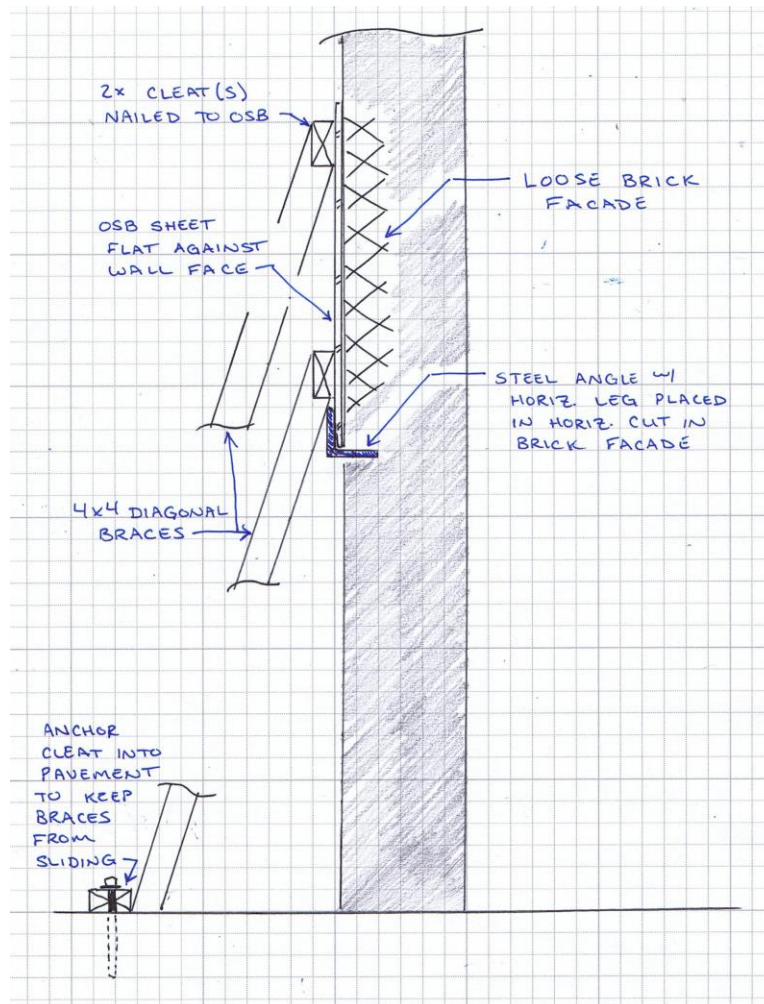
Separately, and with no apparent accompanying narrative, SSE issued a temporary façade shoring sketch on February 9, 2023 (**Appendix A: Fig. 37**). There are no photographs of this shoring being installed at the Building. However, this sketch was referenced in later SSE correspondence, and similar shoring attempts were implemented during the late May 2023 repair work.

Fig. 37. SSE shoring sketch dated February 9, 2023.

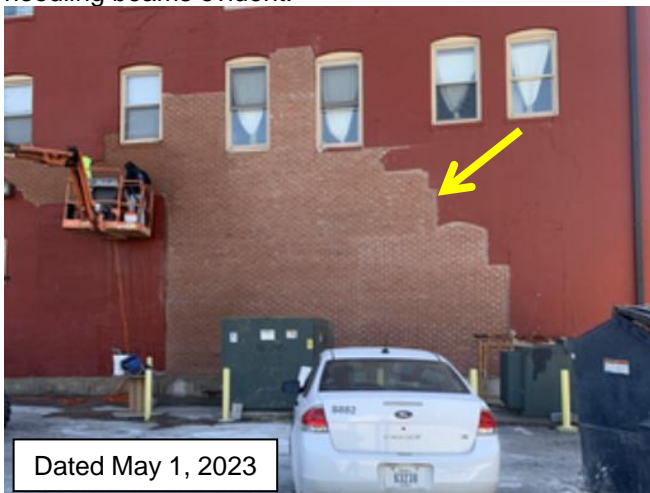
Photograph indicates area of repaired (unpainted) brick from outside building.

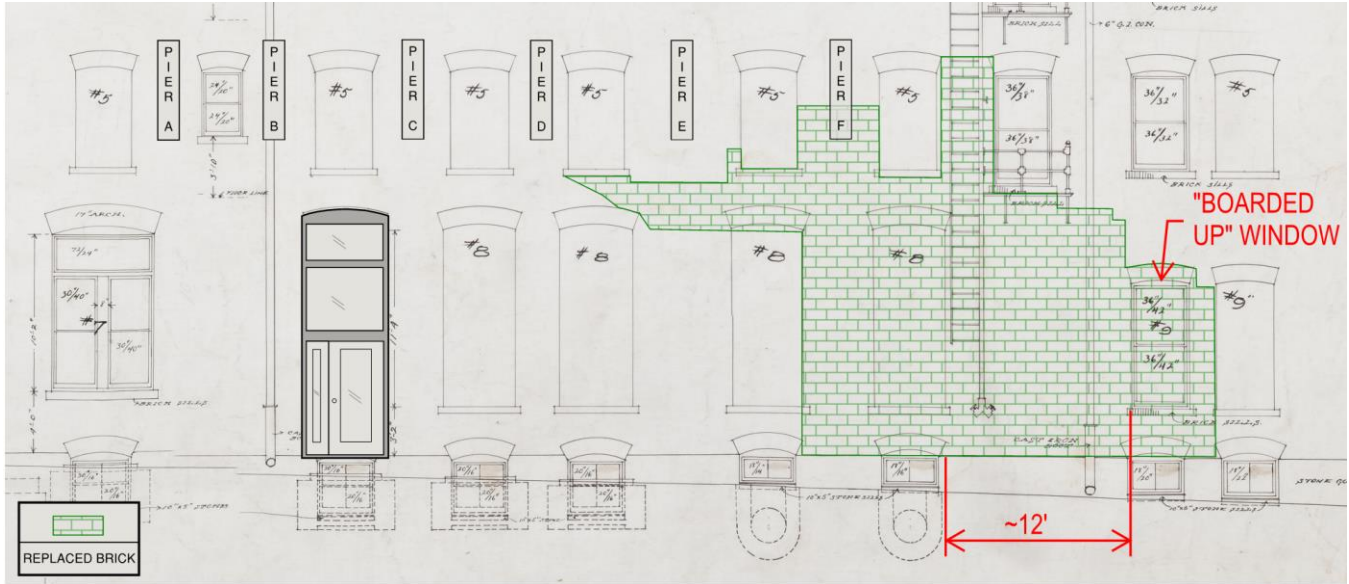
licensed Design Professional provided input regarding how these repairs were to be performed. **Fig. 40** indicates the extent of the actual work area based on photographs reviewed by WBG and SEI.

Fig. 40. West elevation markup indicating actual apparent areas of work completed through May 1, 2023.

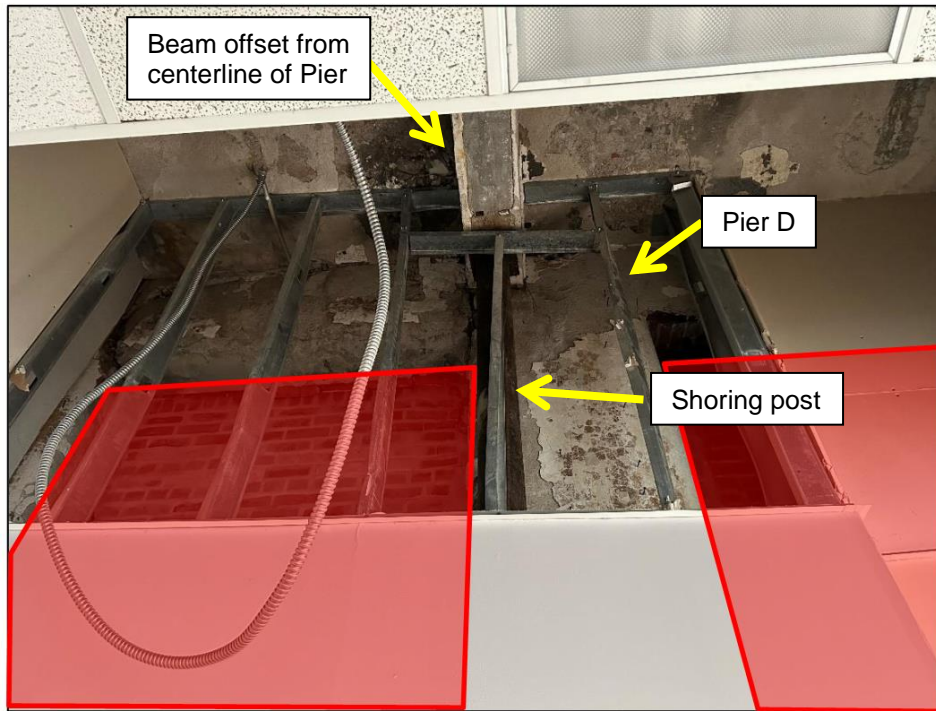
Photo 2 – Window Openings to Infill

SSE also included an image of the interior of the building at the location of these window openings. WBG and SEI have previously identified this Pier as “Pier D” in **Section 4** of this report. The image appears to indicate a steel shoring post contained within the interior finishes. Note this shoring post and the structural beam it is supporting , are located eccentric to the centerline of the Pier. See **Fig. 42**.

Fig. 42. View of the interior of the building from SSE’s May 24, 2023 letter. Red annotation by SSE. Yellow arrows by WBG and SEI.

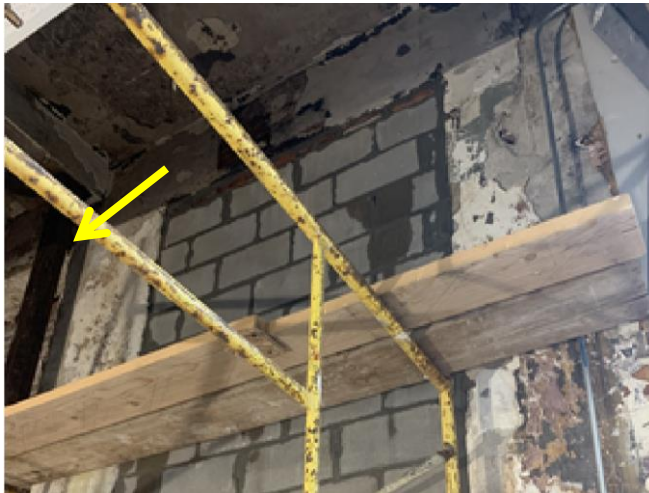
Photograph indicates inside of building with CMU installed inside window opening. Note shore previously identified at Pier D (yellow arrow).

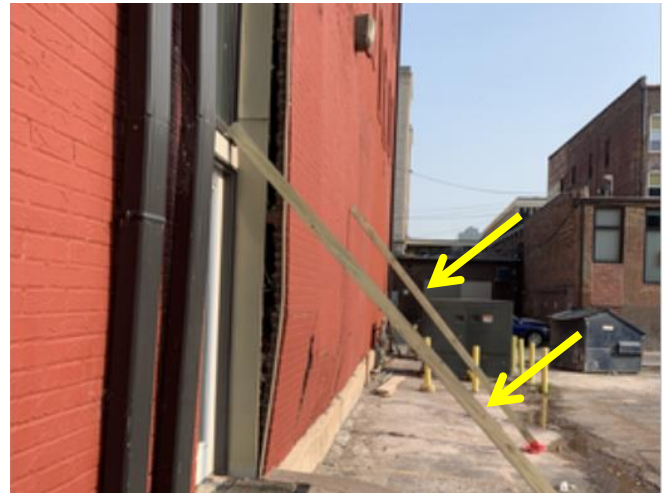
Photograph indicates area of bowing brick south of doorway. Note “shores” in place that do not appear to conform with SSE’s design.

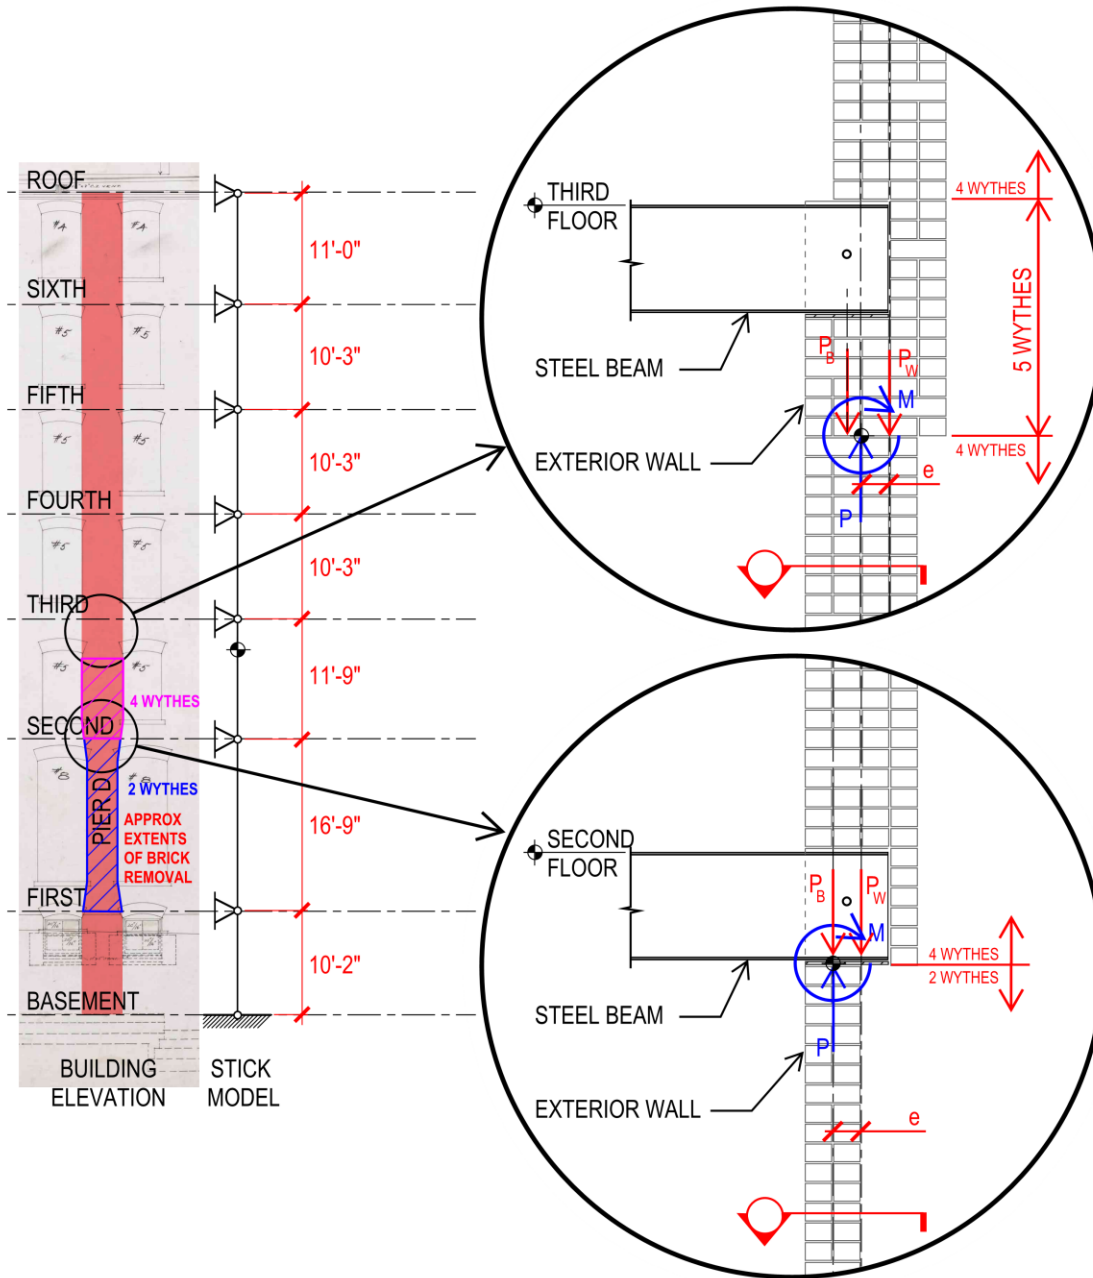
Fig. 44. Wall sections at areas of removed brick at Pier D

As discussed previously in this report, prior to the collapse, the west exterior wall had been partially demolished at the lower levels as part of the specified repairs. Up to three of the outer wythes of brick were removed at differing elevations along the length of the wall. Where this condition existed, the resulting eccentricity (offset from center line) would cause significant bending stresses to be induced into the wall. See **Fig. 44**.

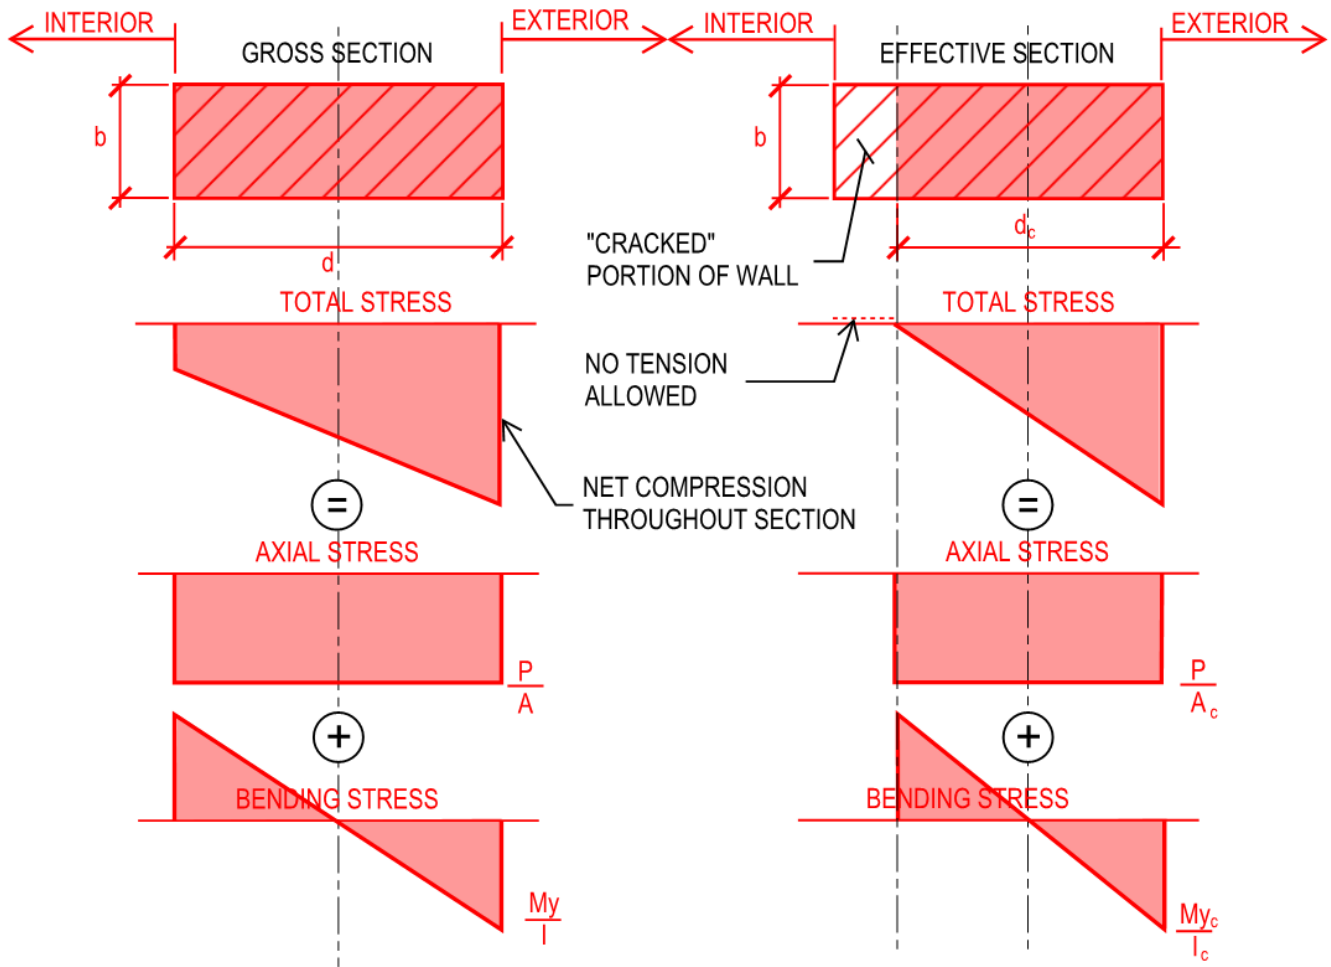
Fig. 45. Assumed stress distribution in wall section

Since the code equations are derived for design purposes to produce safe structures with significant factors of safety (typically a factor of safety of 4), first principles of stress distribution have been used to determine the actual capacity of the wall more accurately at the time of collapse, see **Fig. 45**.

When the axial force is applied at an eccentricity beyond the “kern” of the member (outside the middle third of the section), the member goes into net tension on its outer fibers. Based on the observed condition of the wall at the time of collapse, the known limited tensile capacity of brick masonry, as well as the age of the structure, it has been assumed that no tension is allowed to develop in the section. Thus, a reduced “effective” section must be considered for stress balancing for load applied at an eccentricity beyond the kern of the member. The following equations and derivations form the basis for the analysis of the wall.

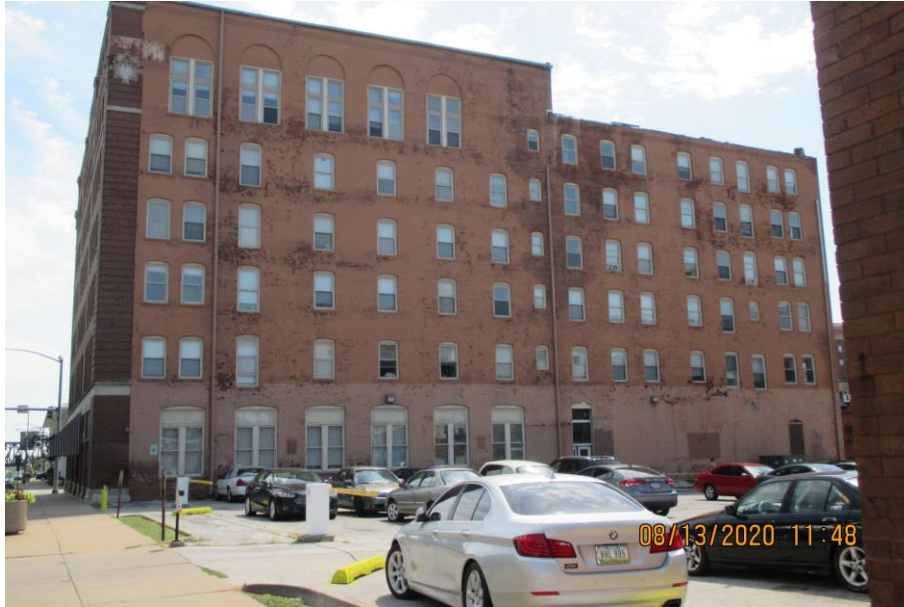
Photograph 1: August 2020 Image of west elevation from City report.

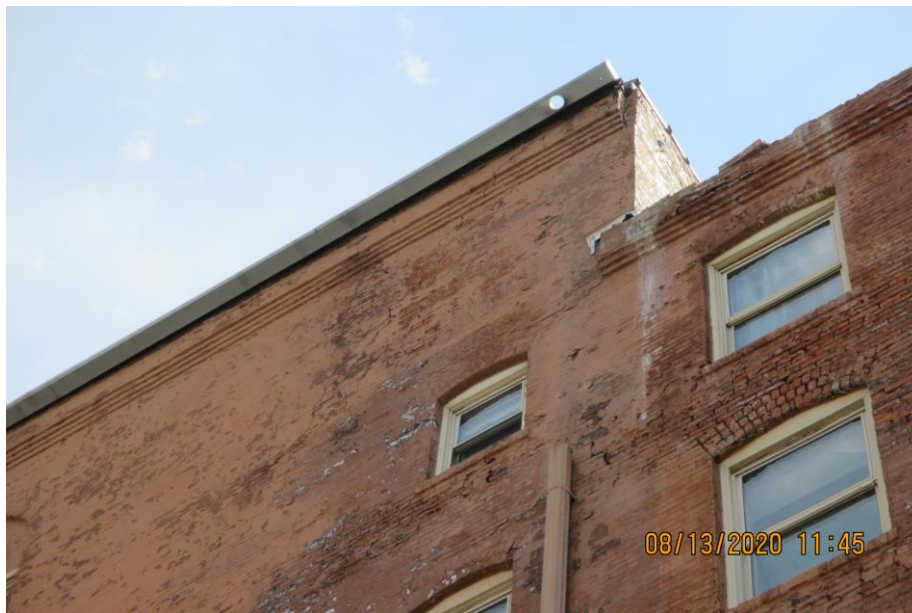
**Photograph 2: August 2020 image of west elevation from City report.
Note open mortar joints and masonry distress.**

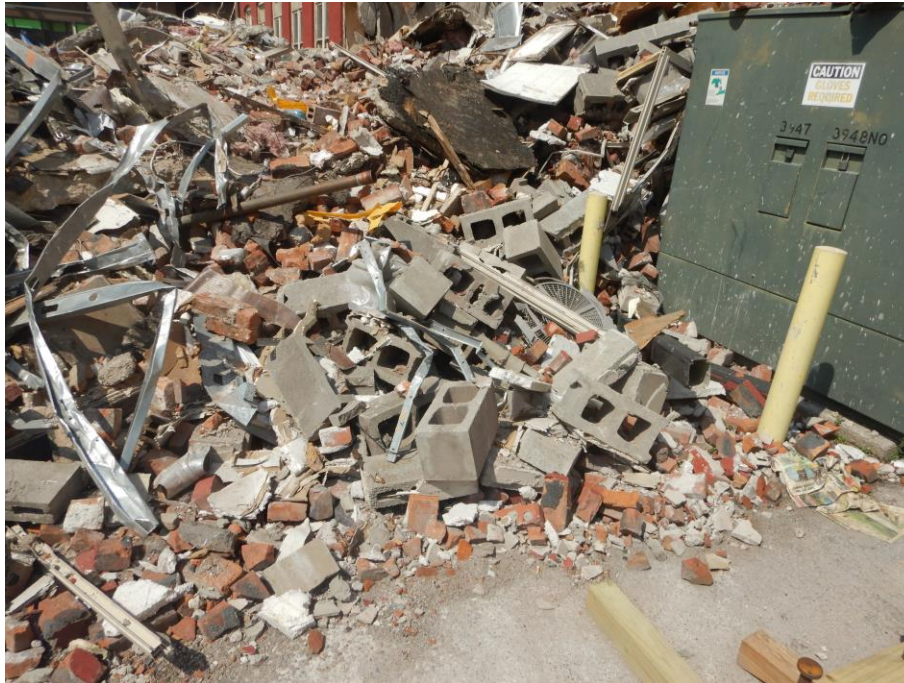
Photograph 17: Post-collapse photo of west elevation wall debris.
Note lack of reinforcing steel or grouted cells in CMU wall component debris

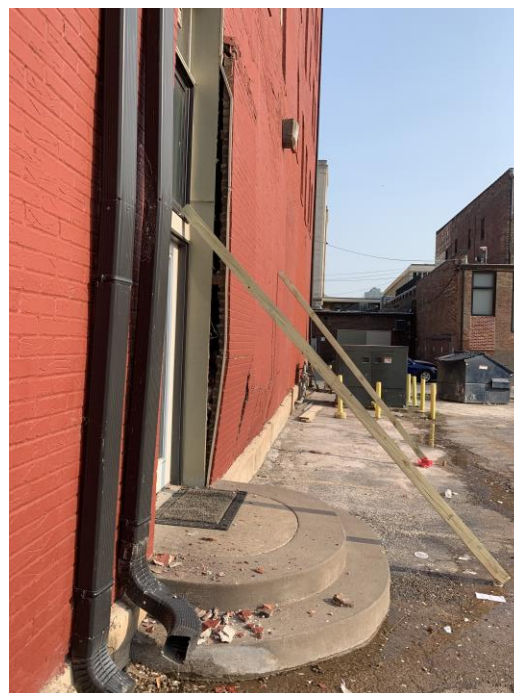
Photograph 22: May 25, 2023 image from City file 32-30329.

Note bowing masonry wall and inadequate shoring attempt.

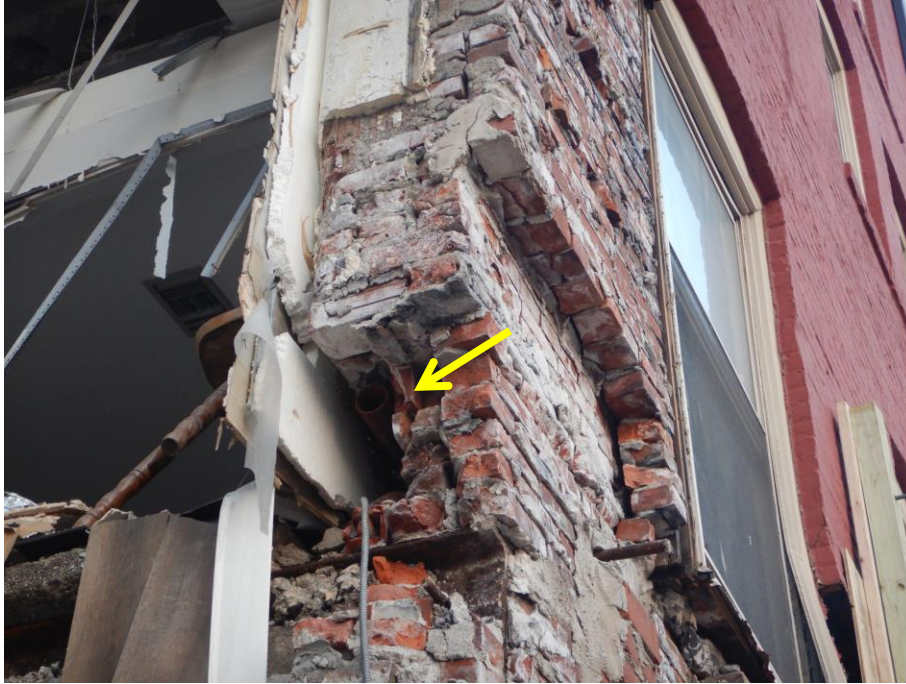
The construction drawings, in addition to pre- and post-incident imagery, indicate the presence of utility chases within the west elevation wall. The number of wythes of masonry reduces at each of these chase locations (**Photograph 23**). Some of these locations are not indicated in the drawings but were visible only through review of photographs and on-site observation (**Photograph 25**).

Photograph 25: Post-collapse image of cross section of wall.
Note reduced wall thickness at location of plumbing embedded within wall at Pier G.

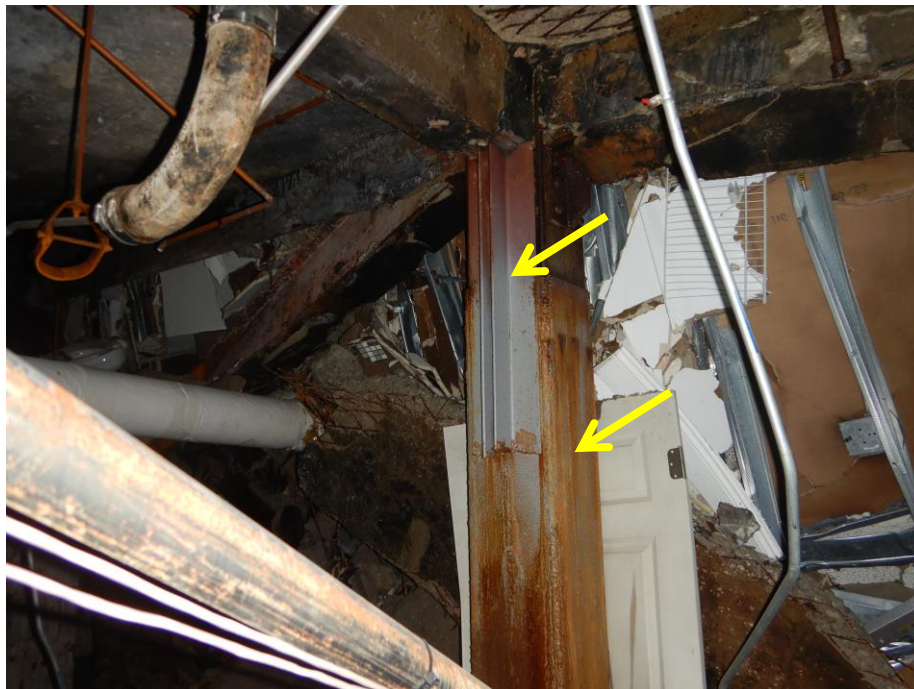
Lastly, several basement columns exhibited reinforcement at the connection to the beams framing into said column (**Photograph 33 and Photograph 34**). The column cover plating and supplemental steel angles suggest a deficiency at this connection location. It is unknown if this condition was due to ongoing water infiltration and resultant corrosion, or some other overstress condition.

Photograph 34: Image and annotation by WBG/SEI of basement column.
Note cover plates and steel angle beam seat reinforcement.

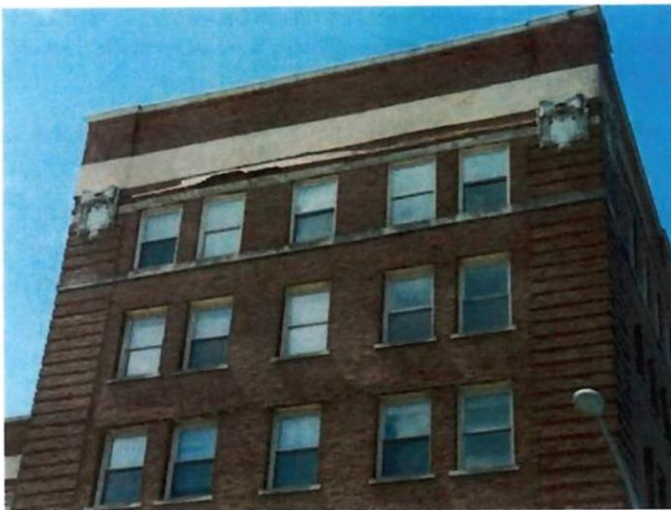
1. East side of the northeast corner. Notice fallen brick above windows.

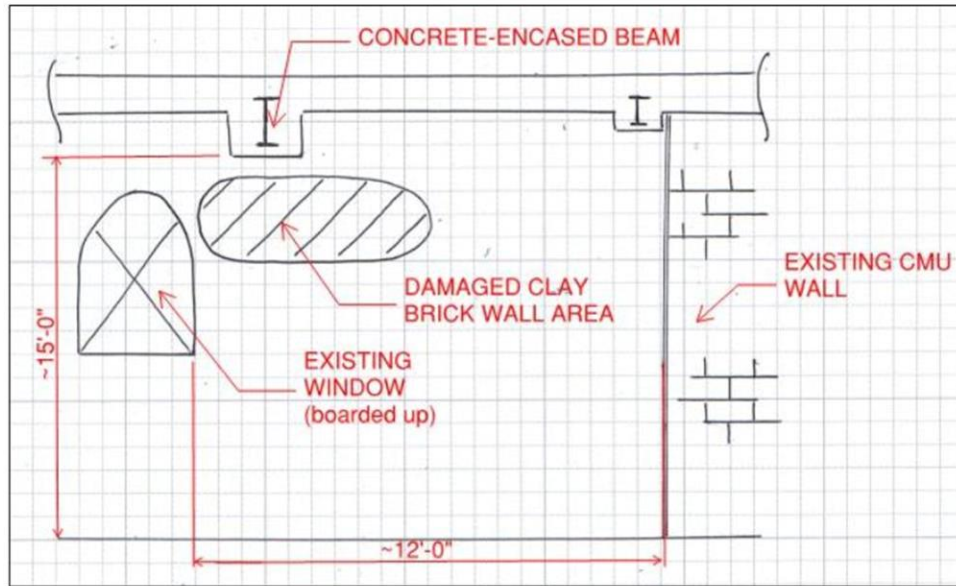
Figure 1 – Current Wall Condition

Figure 1 from the letter (included as **Fig. 34** in this report) indicates the extents of the observed distress (and therefore area of repair) as viewed from inside the building.

The repair specifically calls for a replacement of a wall in only a 12 ft wide segment to the north of a boarded up window. No overall elevation of the building was provided by SSE but it is interpreted that this window was the one included in an image produced by the City, and included as **Fig. 35** in this report.

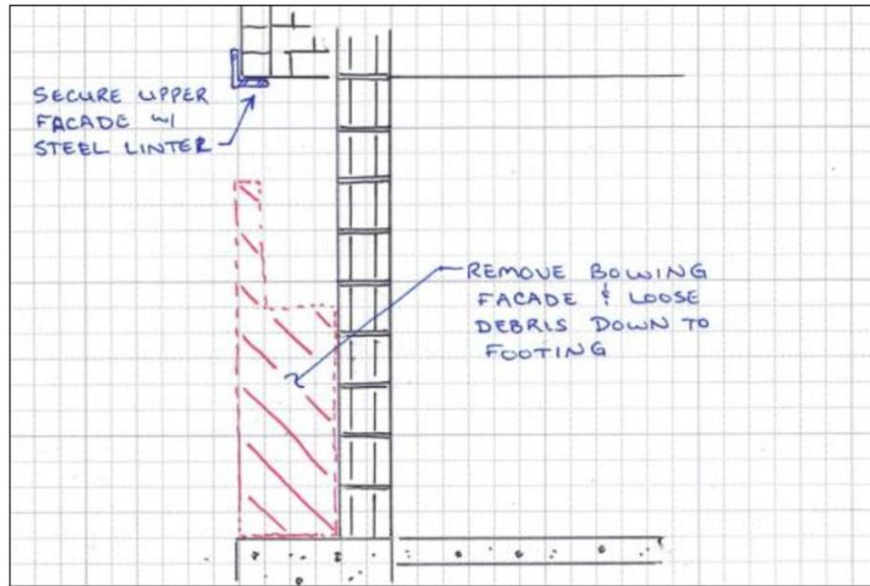
Figure 2 – Brick Demo

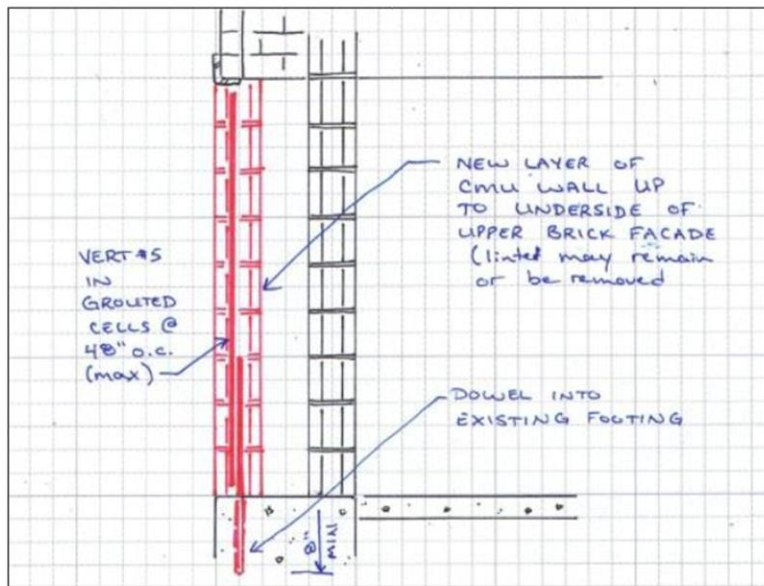
Figure 3 – New CMU Wall

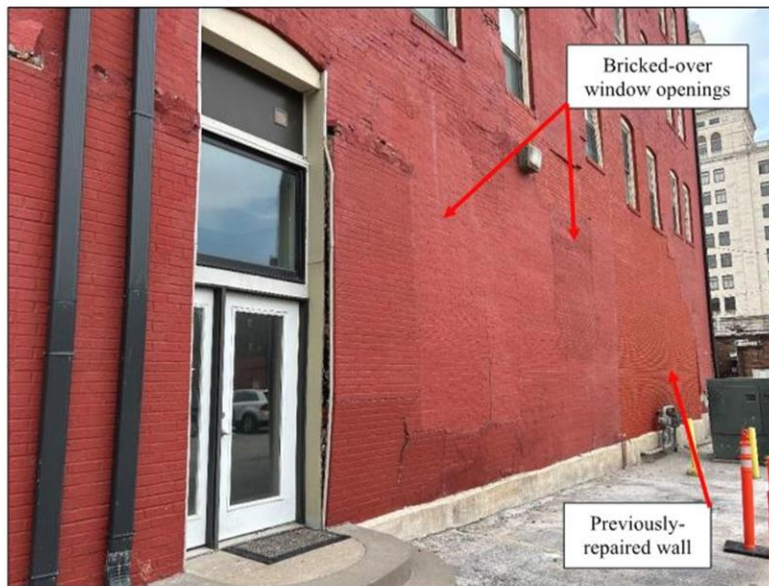
A follow-up site visit was performed at the property above on May 23rd. On the west face of the building, there are several large patches of clay brick façade which are separating from the substrate. These large patches appear ready to fall imminently, which may create a safety hazard to cars or passersby. The owner has already blocked off the area with cones and has begun removing drywall from the inside of the wall to get a view of what might be happening.

Photo 1 – Clay Brick Façade pulling away from Substrate
